# Manhole Inspection Summary

Manhole # S29CC1023MH

Insp Date: **12/14/06 2:58 PM**

**Location** Address: **3700 TUDOR ARMS AVE**

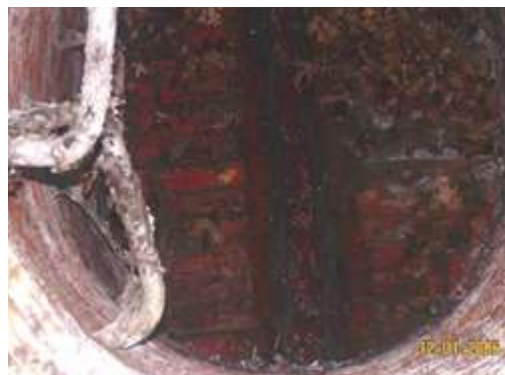
Top View

**Bench** ☒ Exists Material: **Brick** ☐ Parged ☒ **Debris** (not Condition related)

**Steps** Count: **6** Missing: **0** ☒ **Corroded**

**Surcharge** ☒ **Evidence Of Surcharge** Depth: **1.5** (ft.) ☐ Active Surcharge Present

Corroded steps. Evidence of surcharge - Bench debris.

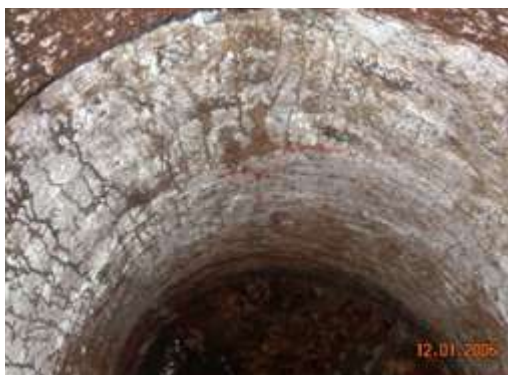
Defect

Infiltration: ☐ None ☒ **Joint** ☐ Cracks ☐ Mortar ☐ Roots ☒ **Wall**

Infiltration: ☐ None ☐ Joint ☒ **Cracks** ☒ **Mortar** ☐ Roots ☒ **Wall**

Adjustment and Barrel infiltration.

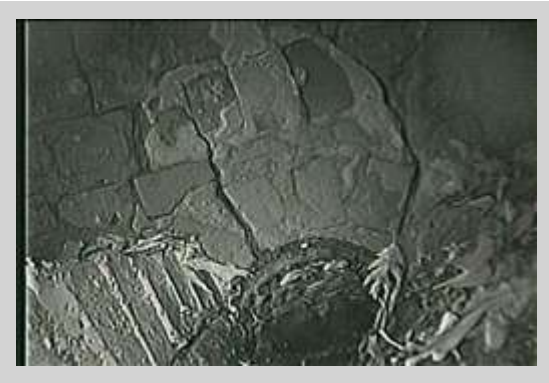
### 8 in. Circular Gravity Sewer Pipe Out @ 12 O'Clock

Condition: ☐ Sound ☒ **Cracked** ☐ Root Intrusion ☐ Loose Brick ☒ **Deteriorated**

Barrel deterioration, cracks and infiltration.

Infiltration: **Evidence** Pipe Seal Cond: **Cracked**

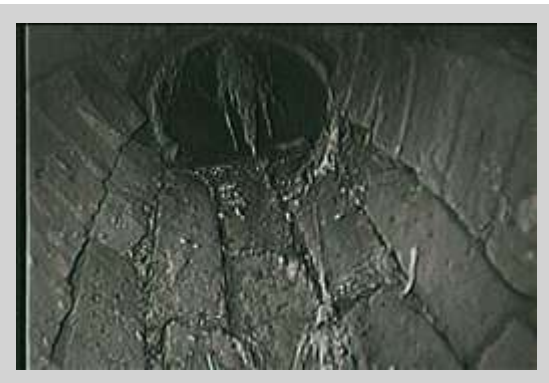
### 8 in. Circular Gravity Sewer Pipe In @ 6 O'Clock

Condition: ☐ Sound ☐ Cracked ☐ Root Intrusion ☒ **Deteriorated** ☐ Leaks ☐ Debris

Channel deterioration.

Infiltration: **Evidence** Pipe Seal Cond: **Roots**
